Compliance Crash Testing of the Caltrans
Type 26 Bridge Rail (732SW)

Crash Testing the Revised Type 26 Bridge Rail

A taller version of the Type 26 pedestrian barrier rail meets crash testing guidelines

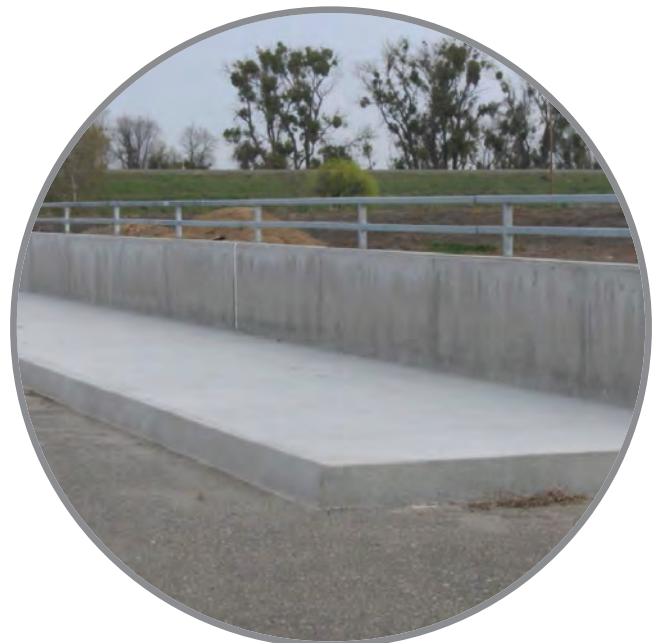
Type 732SW
bridge rail

Since 1973, Caltrans has used the Type 26 bridge rail throughout California along routes with pedestrian walkways and posted speed limits of 45 mph or less. The bridge rail is a vertical, reinforced concrete wall on a sidewalk with a steel-tubular pedestrian handrail or chain link fence on top. Over the decades, the Type 26 has functioned well, however it has never been crash tested. A project to assess its crashworthiness was initiated in the early 2000s but redirected to test a higher priority structure. When testing was ready to be restarted, the Federal Highway Administration (FHWA) had released new guidelines, the *Manual for Assessing Safety Hardware* or MASH 09. Because the Type 26 would likely not meet the more stringent MASH criteria, Caltrans developed a taller and stronger version, called the Type 732SW. The sidewalk is also wider to comply with Americans with Disabilities Act (ADA) requirements. Caltrans then needed to determine whether the Type 732SW met the crash-testing guidelines.

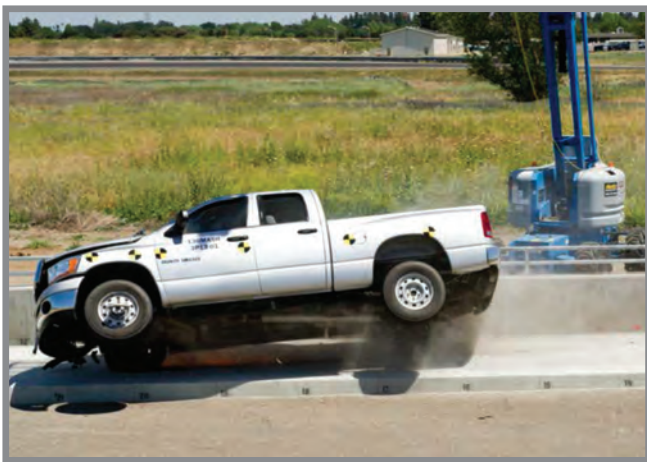
Pickup test impact

To test whether the 732SW bridge rail met MASH 09 Test Level 2 for longitudinal barriers, Caltrans built a test section at the Caltrans Dynamic Test Facility in West Sacramento. MASH 09 Test Level 2 consists of two crash tests: an 1,100-kilogram (kg) car at 70 kilometers per hour (km/h) and a 25-degree impact angle, and a 2,270-kg pickup truck at 70 km/h and a 25-degree impact angle. All vehicles had standard equipment and front-mounted engines. To ensure that the barrier is strong enough to withstand higher speed impacts, the pickup truck test was conducted at Test Level 3 (100 km/h and a 25-degree impact angle). MASH 09 recommends that crash test performance be assessed according to three factors: structural adequacy, occupant risk, and vehicle trajectory. The researchers video-recorded each crash test and analyzed the data.

The results of the Test Level 3 pickup crash test and the Test Level 2 car crash test were within the limits of the MASH 09 guidelines. Occupant risk was acceptable. Damage to the bridge rail was mostly cosmetic, with no structural damage to warrant immediate repair, if any. For all tests, the vehicles were in good condition, free of major body damage and not missing structural parts. The researchers submitted the videos and report to the FHWA for federal-aid eligibility to use the Type 732SW on California highways requiring Test Level 2 bridge rails with pedestrian traffic. FHWA approved the Type 732SW by providing a federal-aid eligibility letter on May 6, 2016.

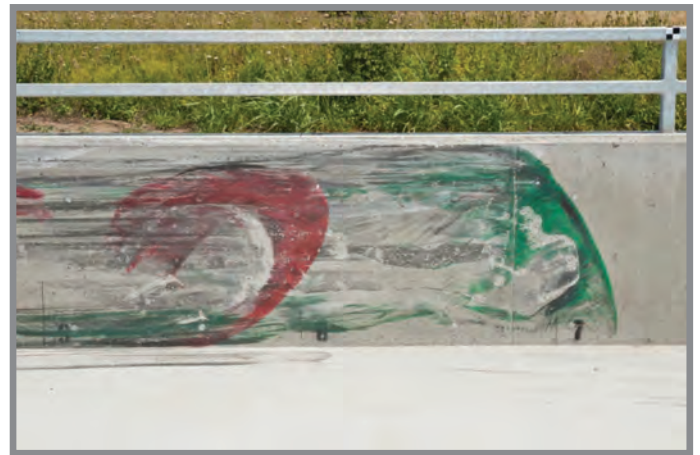
Close-up of the 732SW barrier after a test
